**McMartin**

**Scientific**

**Report**

**THE TUNNELS FOUND AT THE McMARTIN PRE-SCHOOL  
A PRELIMINARY REPORT**

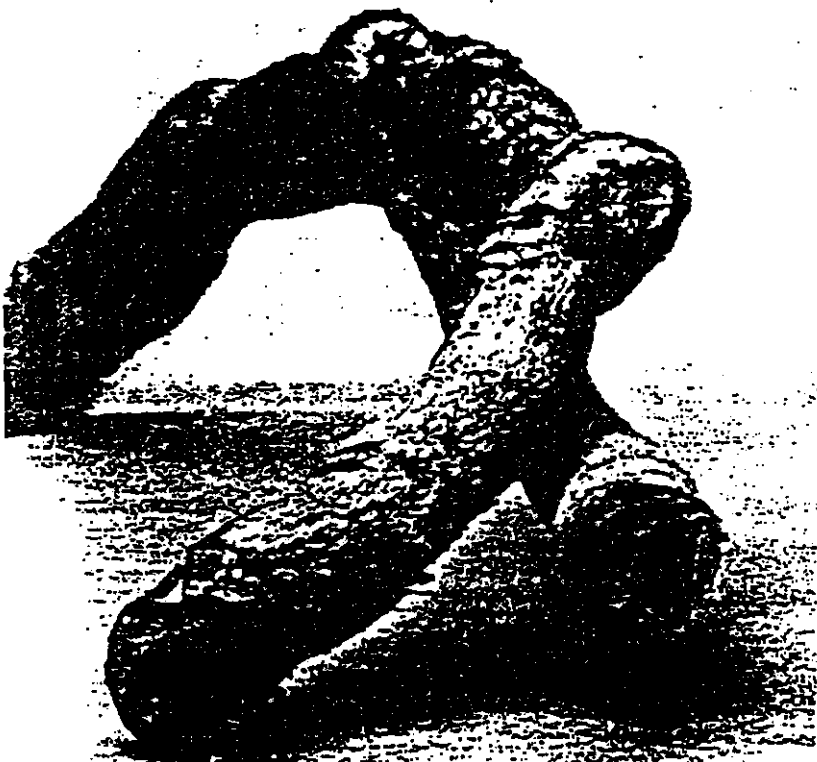
FIGURE 7a: ENDS OF THE SAME ROOTS OF *Ta* SHOWING HEADED END CUTS

FIGURE 7b: ENDS OF THE SAME ROOTS OF *Ta* SHOWING HEADED END CUTS

dried and cracked bark had separated from the root wood by about an 1/8", which indicated to Hobbs that it represented a four to six year old cut, consistent with the time the parent root would have been severed. (Appendix III).
